Manhole Inspection Summary

Manhole # S19A1_011MH

Location Address: **2136 harman av** Cross Street: **tolley-paca alley**

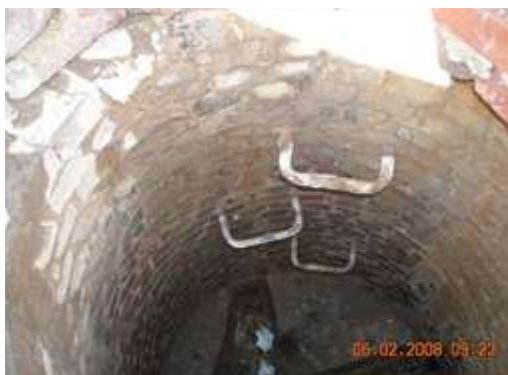
Defect 5

Steps Count: **3** Missing: **1** ☒ **Corroded**

corroded & missing steps

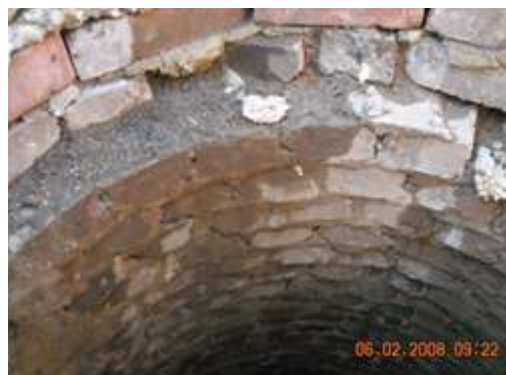
Defect 4

Infiltration: ☐ None ☒ **Joint** ☐ Cracks ☐ Mortar ☐ Roots ☐ Wall

infiltration @ corbel/chimney joint

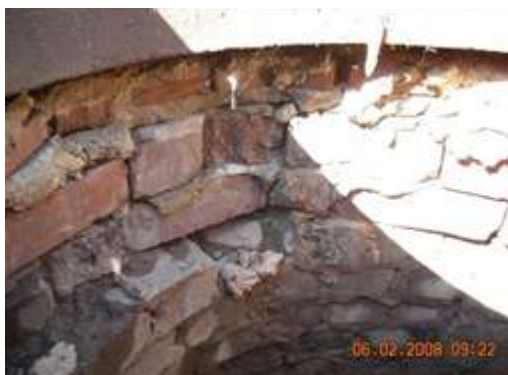
Defect 3

Condition: ☐ Sound ☐ Cracked ☐ Root Intrusion ☐ Loose Brick ☒ **Deteriorated**

deteriorated chimney

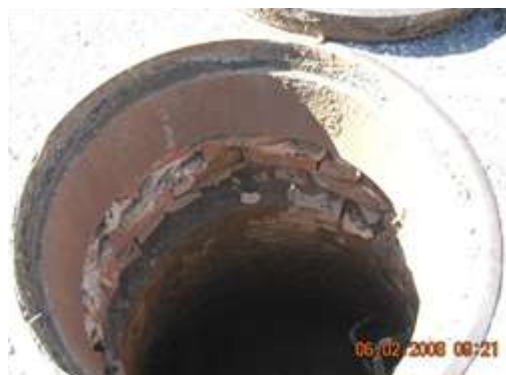
Defect 2

Frame Offset: **1** (in.) Condition: ☐ Sound ☐ Cracked ☒ **Leaks**

Frame leaks-inflow evidence from sheeting

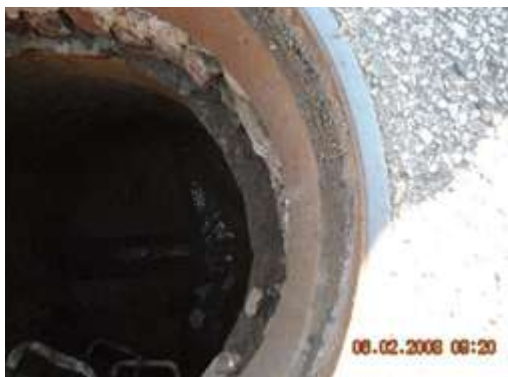
Defect 1

frame offset

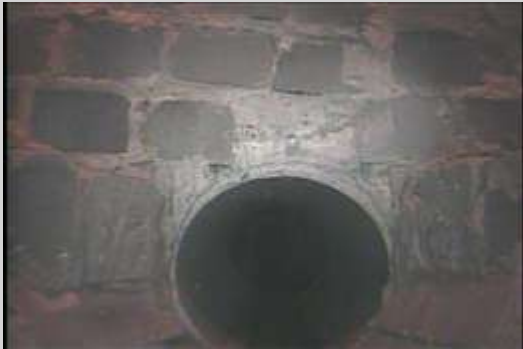
12 O'Clock Outflow

8 in. Circular Gravity Sewer
Pipe Out @ 12 O'Clock

Infiltration: **None** Pipe Seal Cond: **Sound**

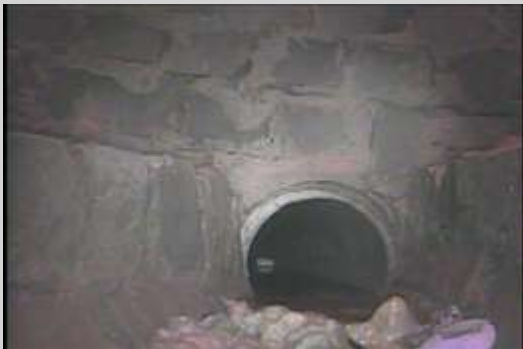
3 O'Clock Inflow

6 in. Circular Gravity Sewer
Pipe In @ 3 O'Clock

Infiltration: **None** Pipe Seal Cond: **Sound**

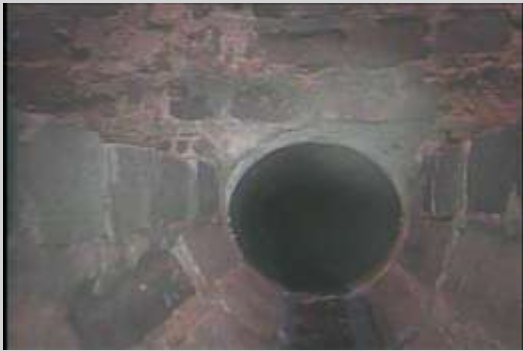
6 O'Clock Inflow

Infiltration: **None** Pipe Seal Cond: **Sound**

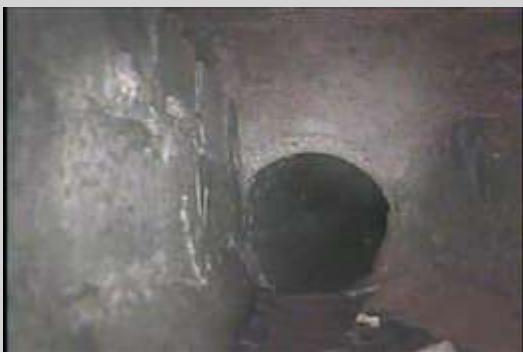
9 O'Clock Inflow

Infiltration: **None** Pipe Seal Cond: **Sound**
